2001 Annual Site Inspection and Monitoring Report for Uranium Mill Tailings Radiation Control Act Title I Disposal Sites

January 2002

2001 Annual Compliance Report Canonsburg, Pennsylvania, Disposal Site

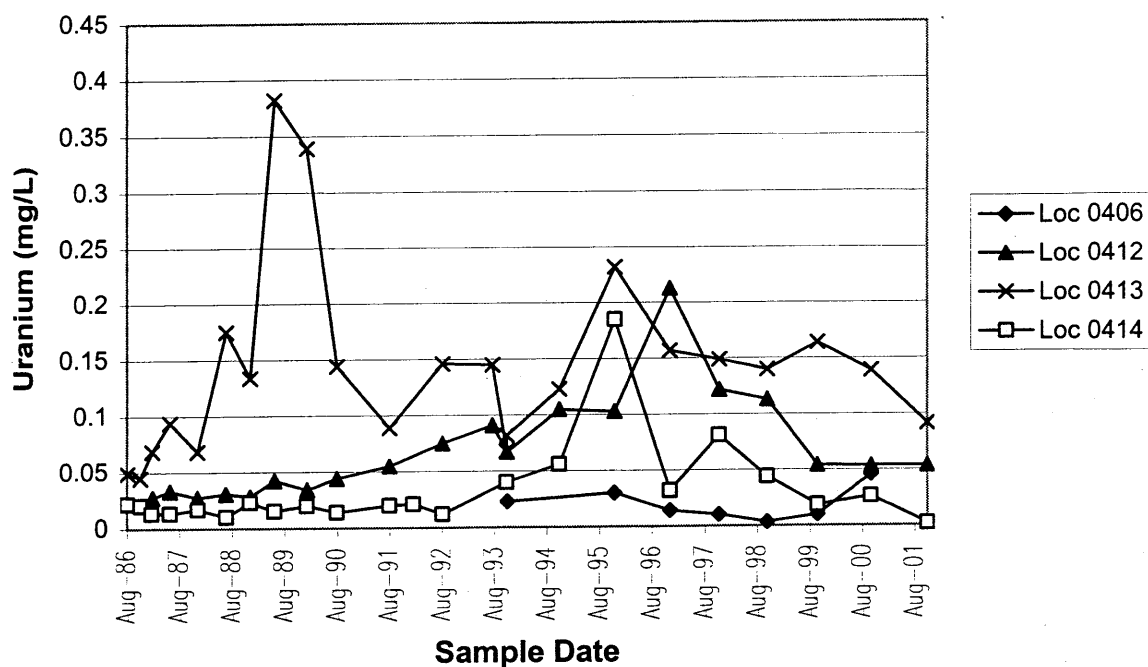
Figure 3-2. Time-Concentration Plot of Uranium in Ground Water at the Canonsburg, Pennsylvania, Disposal Site

In 2001, uranium concentration exceeded the standard at two of the three sampled downgradient wells: 0412 and 0413. All results are consistent with previous results. Although long-term trends in the data are conjectural, short-term trends, since about 1995, may be developing. DOE is cautious on this point because of the wide variations in the historical results (Figure 3-2).

Uranium concentrations have been decreasing since about 1995 at the downgradient wells. The greatest exceedance this year was at well 0413, where the highest levels of uranium have been reported in the past. Uranium concentration was below the required laboratory detection limit at all sampling locations in Chartiers Creek.

The elevated concentration of uranium at some wells, and the wide fluctuations in uranium at these wells over the years, are probably unrelated to disposal cell performance for the following reasons: (1) there is remnant contamination outside the disposal cell; (2) the geochemistry of ground water in the unconsolidated materials beneath the disposal cell is apparently favorable for the mobilization of uranium; and (3) high levels of uranium existed in ground water before construction of the disposal cell. These considerations were discussed at length in previous annual reports.

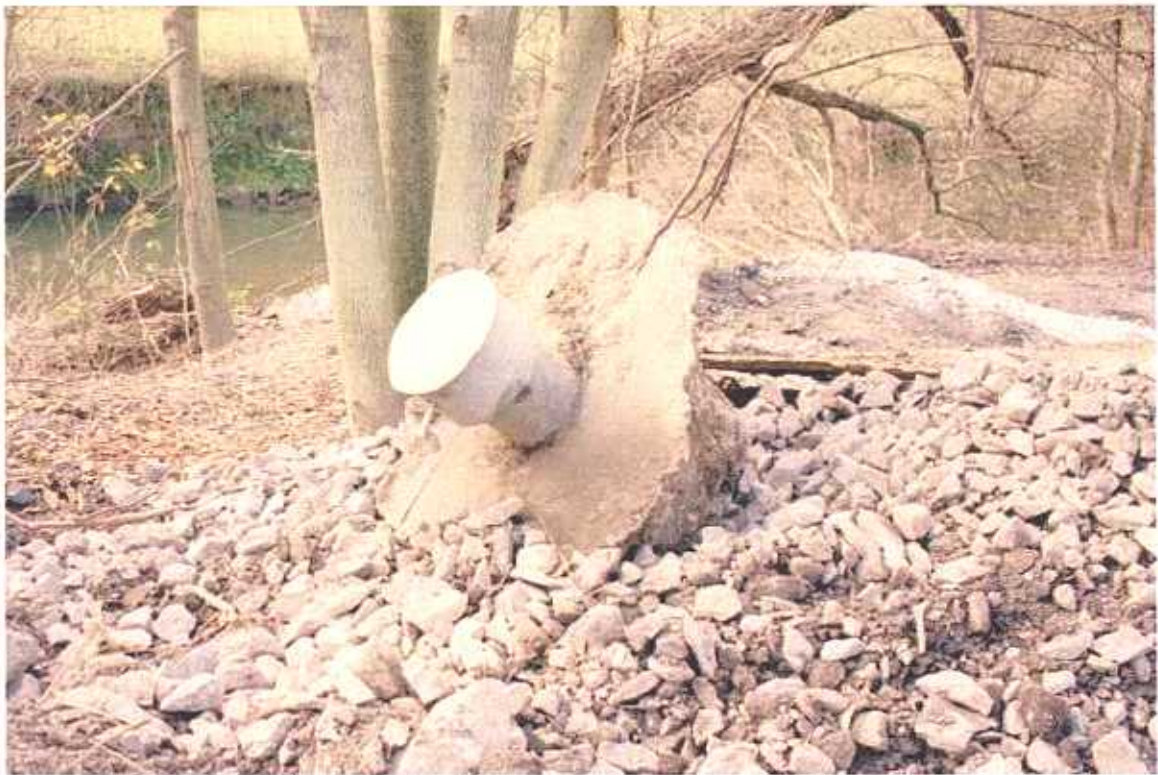
PL-1. Displaced Cap of Destroyed Monitor Well 0406

In addition to annual grass mowing and other measures to manage and control vegetation, inspectors identified the need to replace three perimeter signs and monitor well 0406 in 2002.

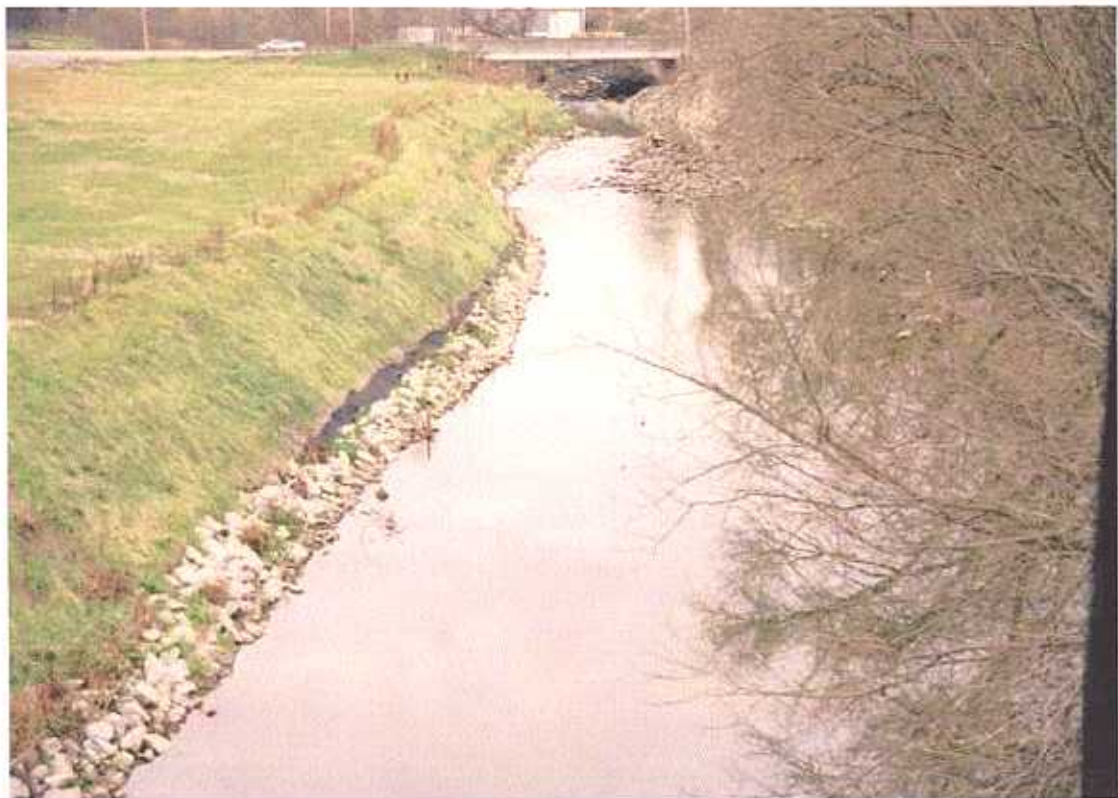
3D Over the years since the completion of remedial action, erosion had occurred along the western bank of Chartiers Creek at Area C. To address this problem, DOE reconstructed and revegetated the bank between December 2000 and May 2001. The site inspection indicated that stabilization efforts were successful (Figure 3–4). Grasses have successfully established on the slope of the stream bank, and willow plantings are beginning to take hold.

PL-2. Stabilized Western Bank Of Chartiers Creek at Area C
